# **INDOOR AIR QUALITY ASSESSMENT**

**Department of Developmental Services  
Hogan Regional Center, Maintenance Building  
7 Hathorne Circle  
Danvers, MA**

Prepared by:  
Massachusetts Department of Public Health  
Bureau of Environmental Health  
Indoor Air Quality Program  
December 2016

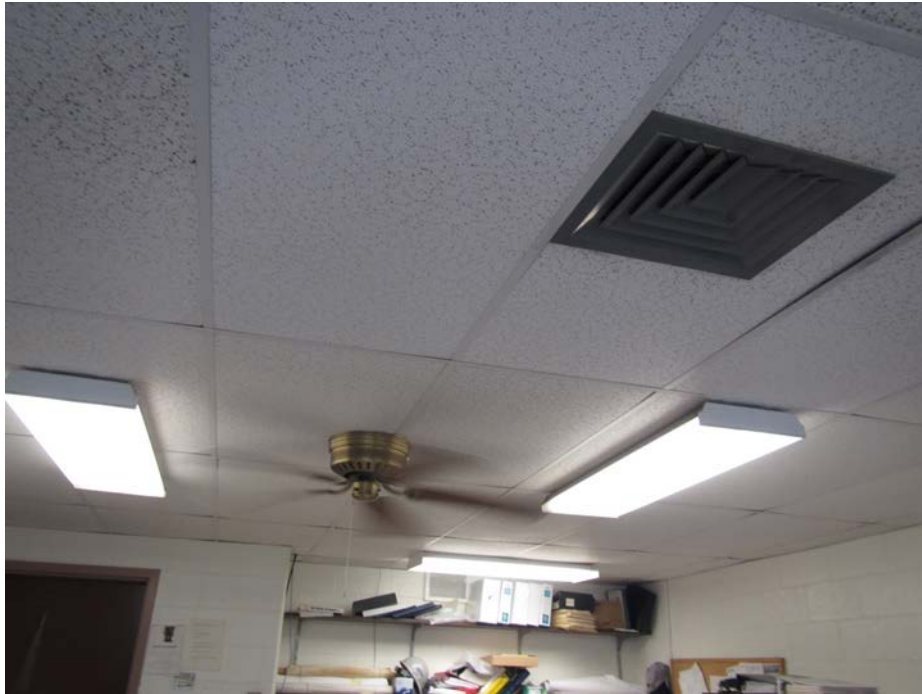
**Picture 1**

The maintenance area consists of a large space on the ground floor and a small space directly upstairs with an office and files. The rest of the building is offices and residences for other DDS functions and was not assessed during this visit. The upstairs room is served by a small air handling unit (AHU). Air is supplied to the space through ceiling-mounted vents (Picture 1). Supply and exhaust ventilation should be on at all times.

**Supply vent in upstairs office**

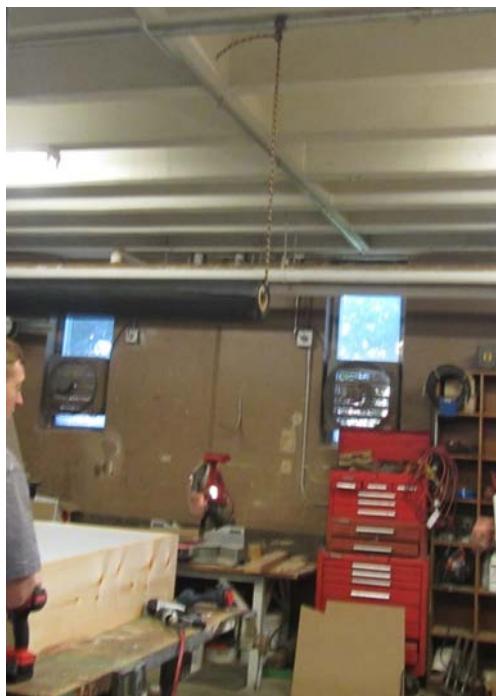
**Picture 2**

The lower floor has no source of supply ventilation. During warmer months, doors to the outside are kept open when the building is occupied, providing fresh air. Two exhaust fans are installed in windows by the saw table (Picture 2), one is installed in the restroom (Picture 3) and one is in the room with the fuel tank for the generator (Picture 4). All are activated by way of a switch.

Due to the age of the building, it is likely that some fresh air is drawn into the building through cracks and seams when the exhaust fans are activated, even when the doors are closed; however a source of make-up air will make the exhaust work better at removing odors and pollutants. The exhaust fans near the saw table should be turned on whenever the shop is occupied even with the exterior door closed.

**Exhaust vents in windows in the woodworking area**

1. Operate the exhaust fans near the woodworking area when woodworking and other pollutant-generating activities are taking place.

2. During the cold season, when the doors are kept closed, consider operating these exhaust vents continuously during occupied periods to provide some air exchange. Consider installing a make-up vent in or next to the door to allow for fresh air during the heating season.

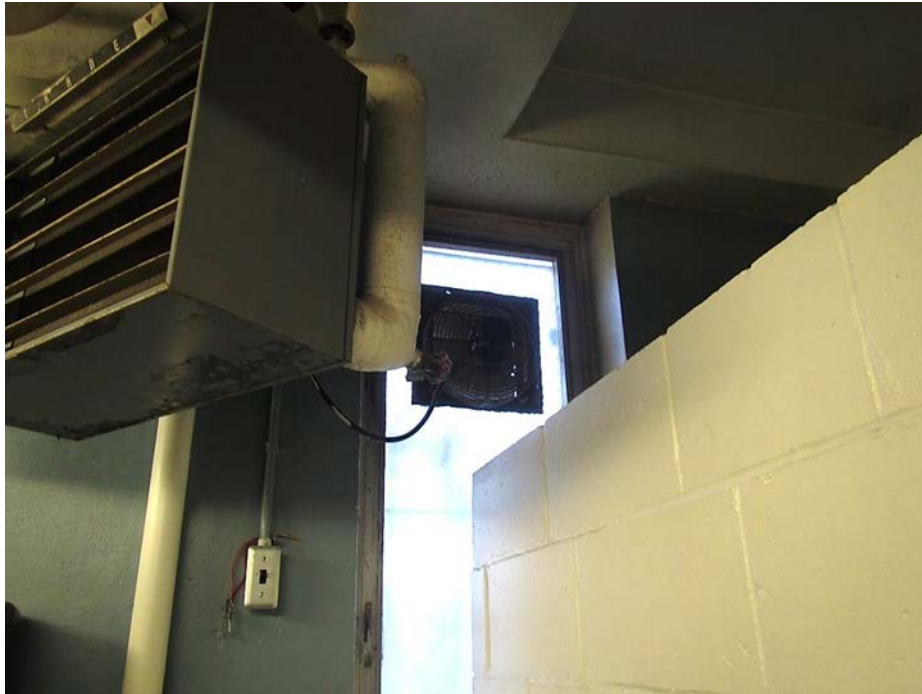
**Picture 3**

Note that heating on the lower floor is provided by source heaters hanging from the ceiling. The ones in the main floor are operated by way of heated water (from a rooftop solar system) and are self-contained (Picture 5). The one in the restroom (Picture 3) is operated by propane and should only be used when the exhaust fan is on.

**Exhaust vent, vent switch, and heater in the restroom**

3. Operate the exhaust vent in the restroom whenever the heater is in use and as needed at other times.
4. Operate the exhaust vent next to the generator fuel tank whenever the tank is being filled or used.

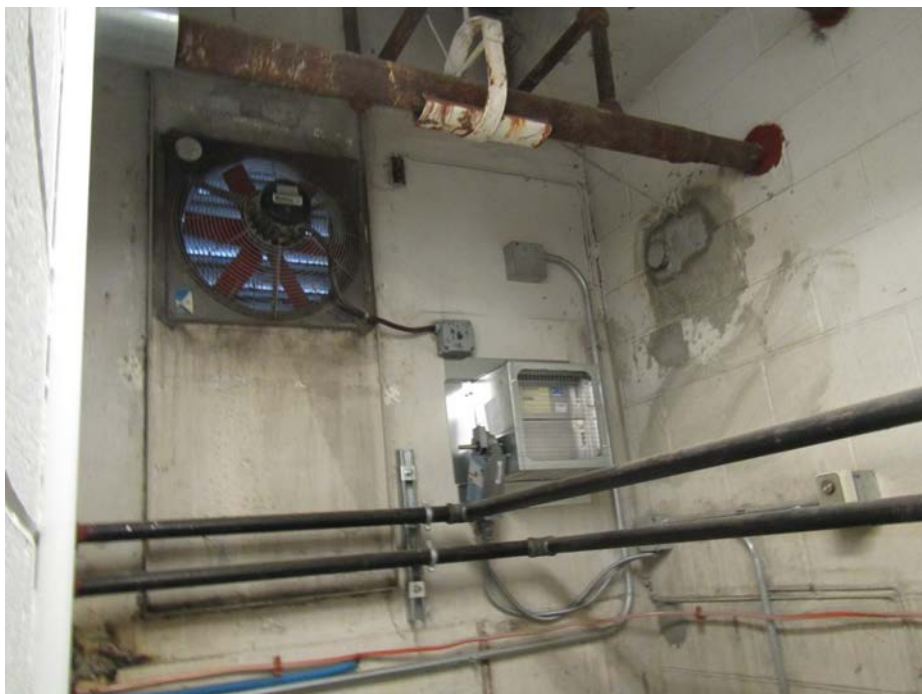
**Picture 4**

**Exhaust vent in diesel tank room**

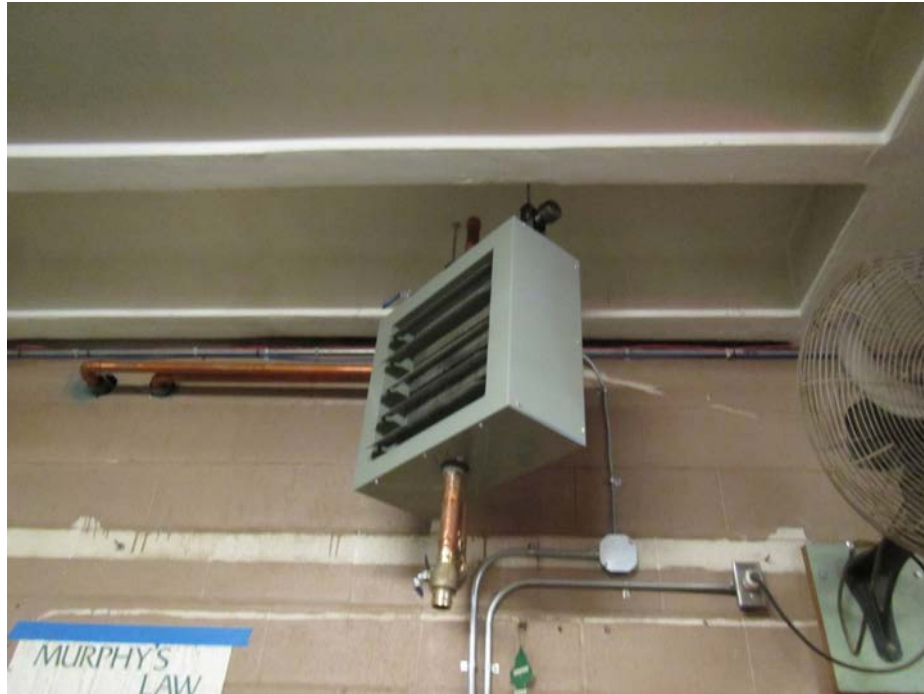
**Picture 5**

**Hot-water-based room heater**

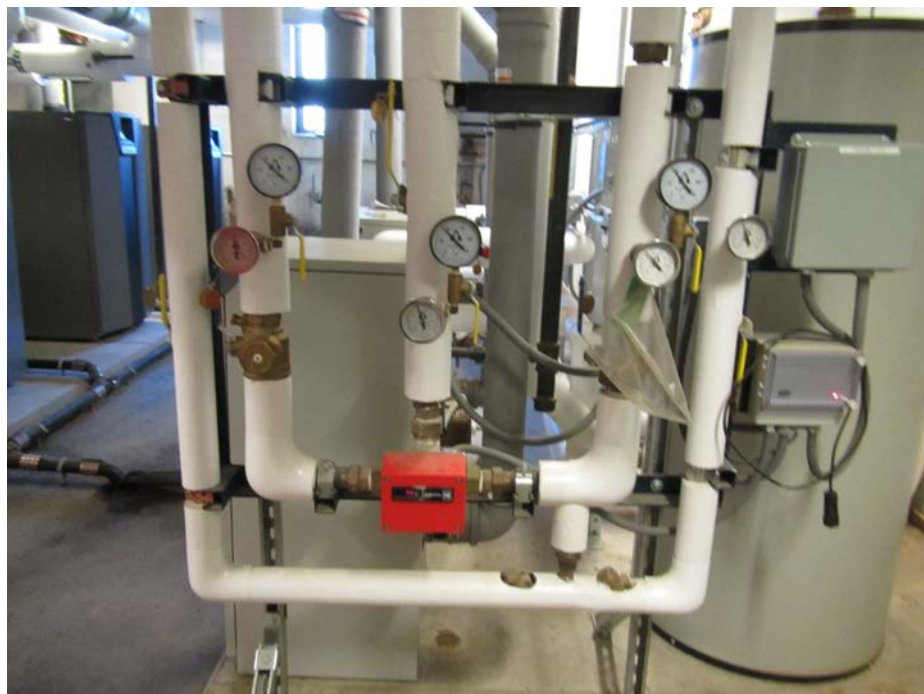
**Picture 6**

There is also a mechanical room adjacent to the shop space (Picture 6). The mechanical room contains the heating and hot water equipment for the building; these units are reportedly new in the last five years and appeared to be clean and in good condition. Doors between mechanical spaces and occupied areas should be kept tightly closed when not in use.

**Inside mechanical room showing new equipment**

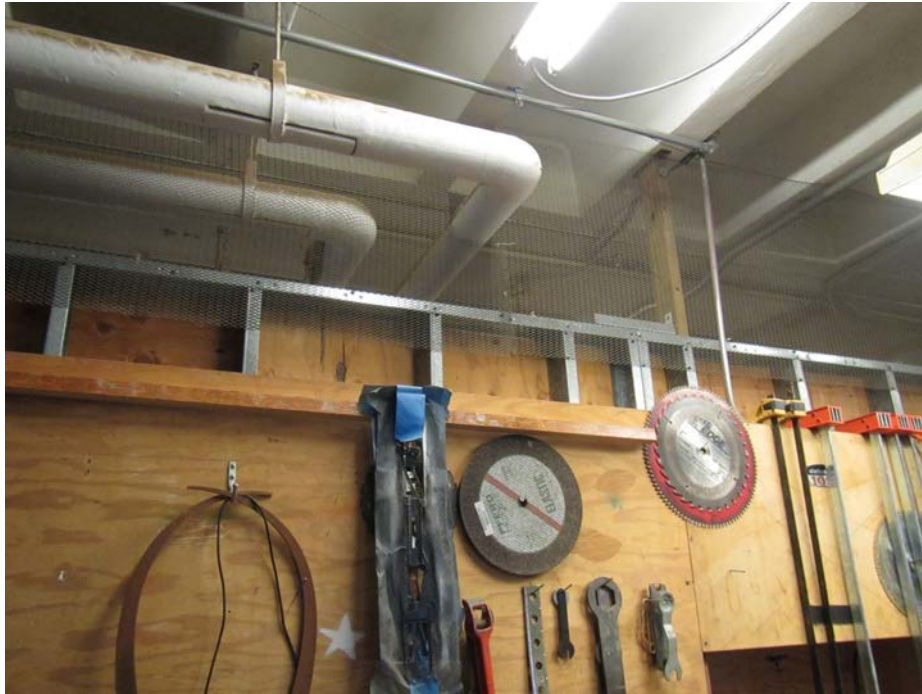
**Picture 7**

There is currently no source of cooled air for the summer in the workshop area, which is reportedly a concern for some of the occupants. The installation of air conditioning for a space of this size can be expensive, as the large open spaces and high ceilings make cooling the entire space difficult. In addition, caution must be used to avoid over-chilling some areas which may lead to condensation on chilled surfaces and water damage of materials. Most of the workshop area is one connected open space. If the occupants wish to install a portable or ductless air conditioning system in a single room to serve as a rest area, the area should be fully enclosed with a tight-fitting door to allow for efficient cooling and prevent condensation from the entry of humid air. An area currently used as a lounge has divider walls that do not stretch all the way to the ceiling (Picture 7), requiring modification if this room were to be fitted with air-conditioning.

**Incomplete wall (with mesh) between woodworking area and room used as a lounge**

5. If cooling is desired to be installed to serve the break area, ensure the area is fully enclosed with a tight-fitting door.
6. If cooling of the entire space is desired, consider consulting with an HVAC engineer regarding the type and size of units that would be needed in a space of this size and configuration.

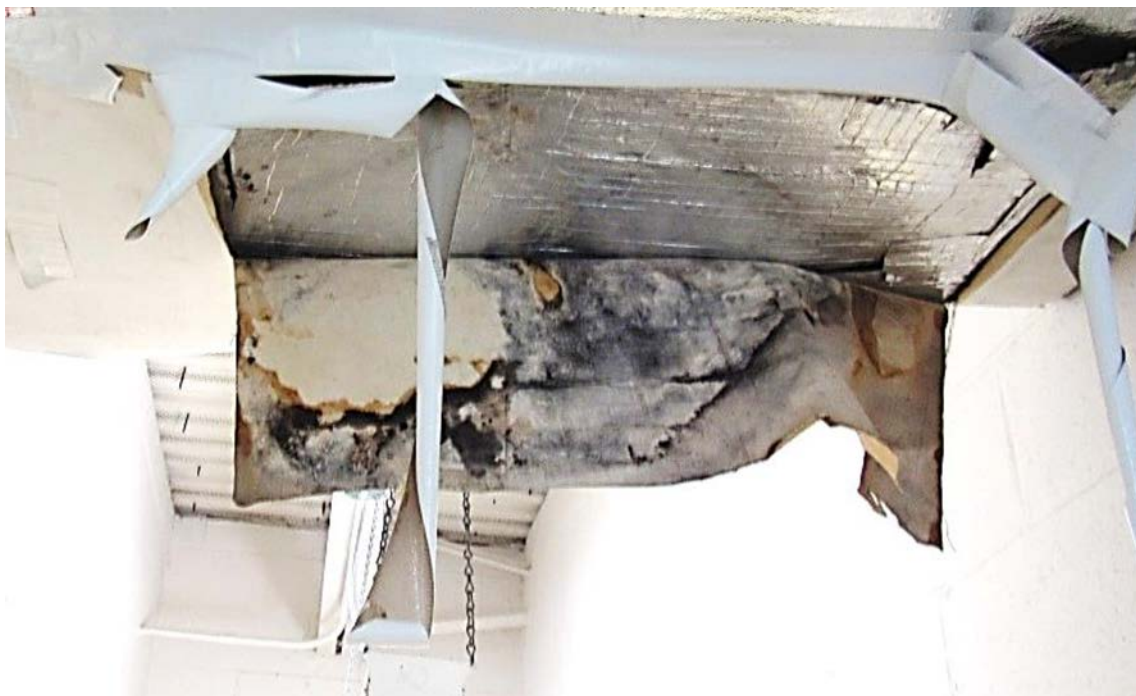
**Picture 8**

Water-damaged, likely mold-colonized materials were found in the stairwell from the offices on the upper level around a portion of an AHU (Picture 8). This indicates that this material has been moistened, possibly from humid air rising along the stairwell, or by AHU leaks. This material should be removed and replaced.

**Water-damaged, mold-colonized wrapper on AHU in the upper part of the stairwell**

7. Repair/replace water-damaged materials around the AHU shown in Picture 8.
8. Avoid storing porous items on the floor to prevent condensation from moistening them.

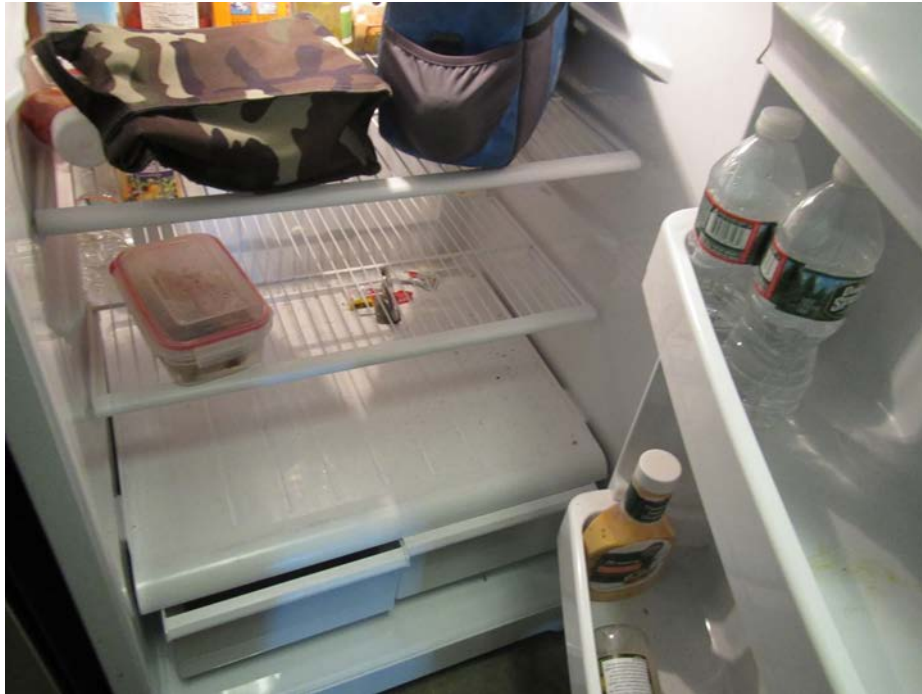
**Picture 9**

A refrigerator in one of the open areas had evidence of spills/stains (Picture 9) which can cause odors. Refrigerators should be regularly cleaned.

**Stains from spills in bottom and door shelf of fridge**

9. Clean refrigerators out regularly.
10. Sort products and items such as paint and lubricants and properly dispose of any that are outdated, not needed, or in damaged/unlabeled containers. Open the flammable cabinet and ensure that no hazardous products are stored inside.

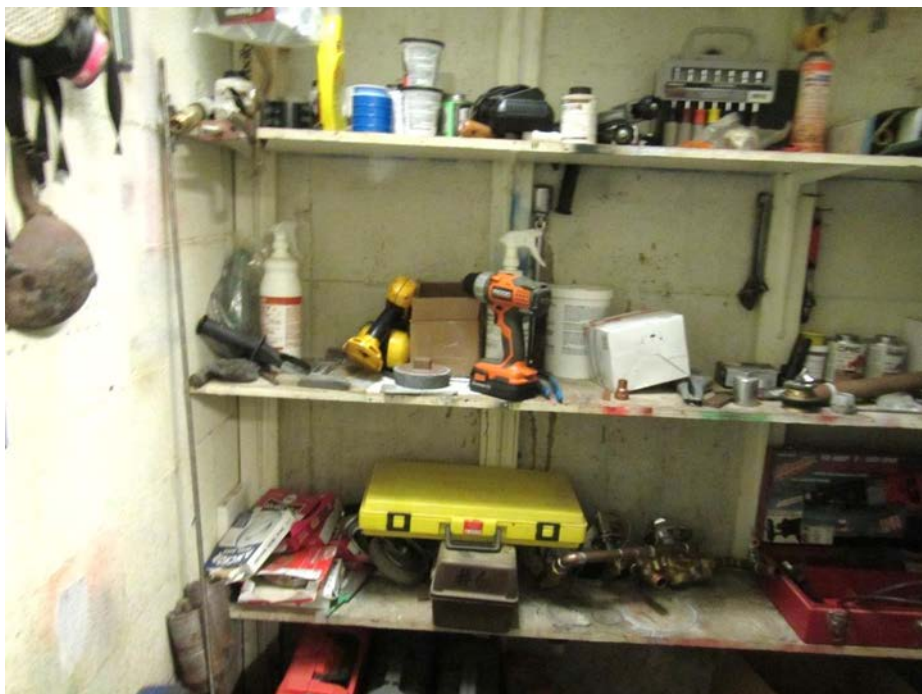
**Picture 10**

Exposure to low levels of total volatile organic compounds (TVOCs) may produce eye, nose, throat, and/or respiratory irritation in some sensitive individuals. Measurements of TVOCs in the space at the time of the visit were ND. Many items and products in the space contain VOCs, including cleaning products, paints, lubricants, and dry erase materials in a number of places (Pictures 10 through 12). All of these products have the potential to be irritants to the eyes, nose, throat, and respiratory system of sensitive individuals. As shown in pictures 10 through 12, many of these materials were found stored in a disorganized manner, missing caps

and improperly labeled. Based on appearance, some of the materials are old and may have undergone container degradation or chemical changes that may increase the chances of release and potential exposure. A flammable materials cabinet was observed in one alcove (Picture 13) with signs of corrosion. The cabinet was stuck closed (Picture 14), so it is not known what, if anything, is currently stored inside.

**Cleaners and other VOC-containing items on a disorganized shelf**

Materials that are outdated or no longer useful should be properly discarded and the remaining materials stored in an organized manner, with clear labels and intact containers. Materials that are incompatible with one another should not be stored together.

11. Store remaining VOC-containing items neatly and appropriately, including proper labelling. Ensure that incompatible products are not stored together.

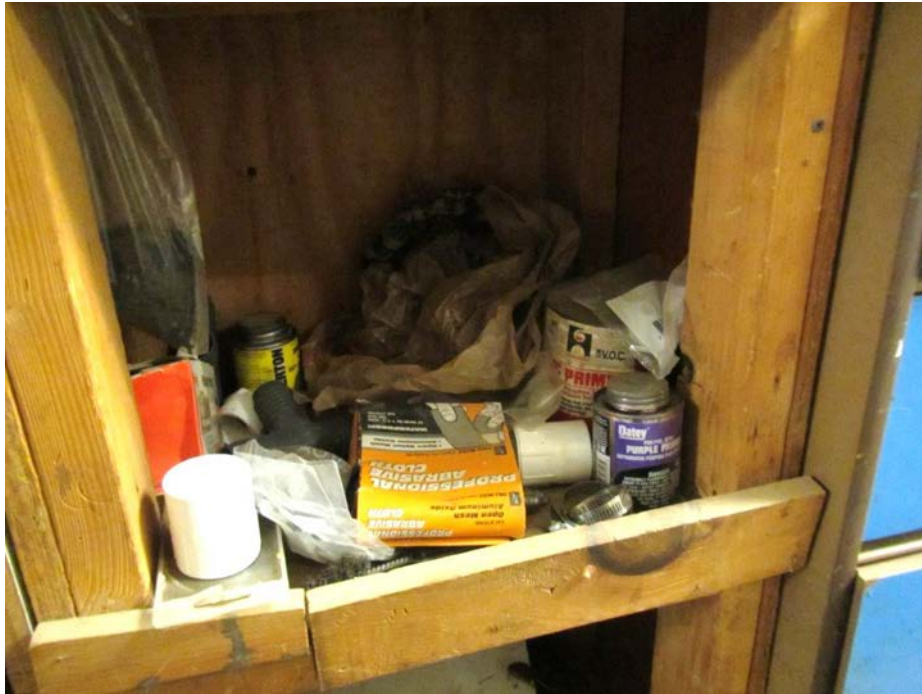
**Picture 11**

**VOC-containing items stored in a disorganized manner**

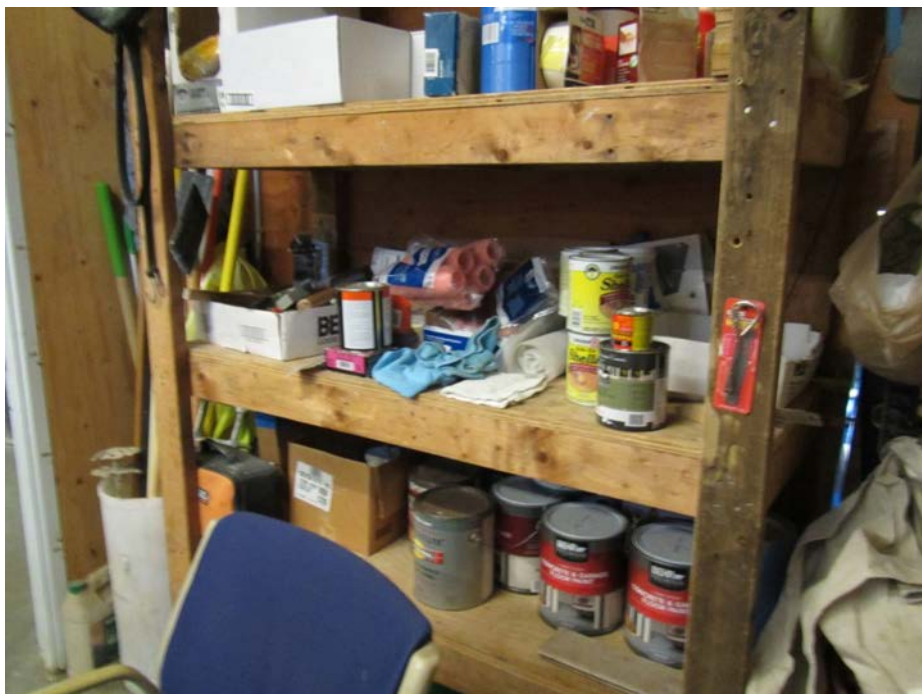
**Picture 12**

**Stored paints**

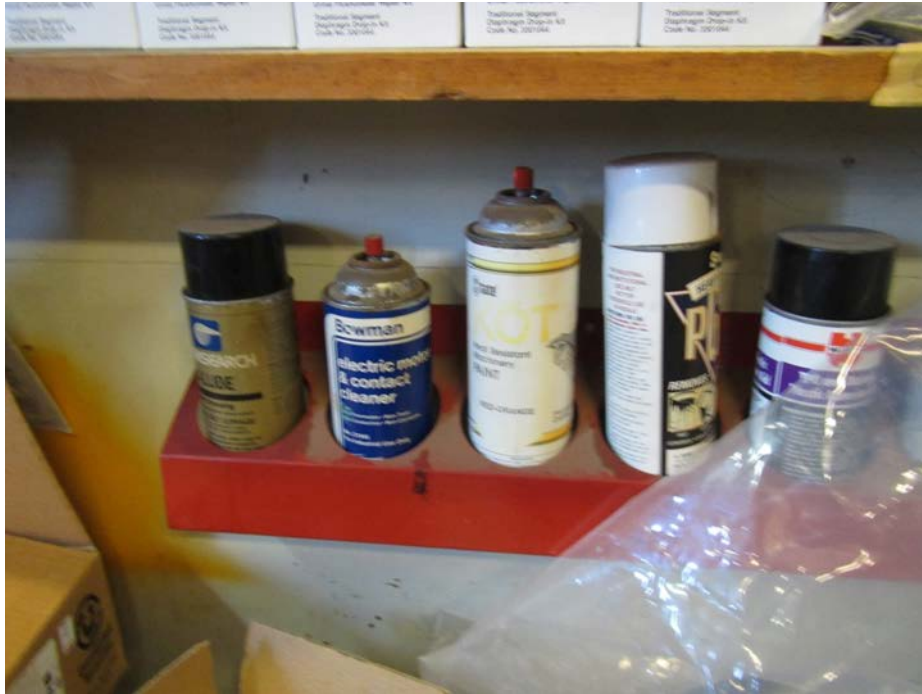
**Picture 13**

**Cleaners and spray paints, some without caps**

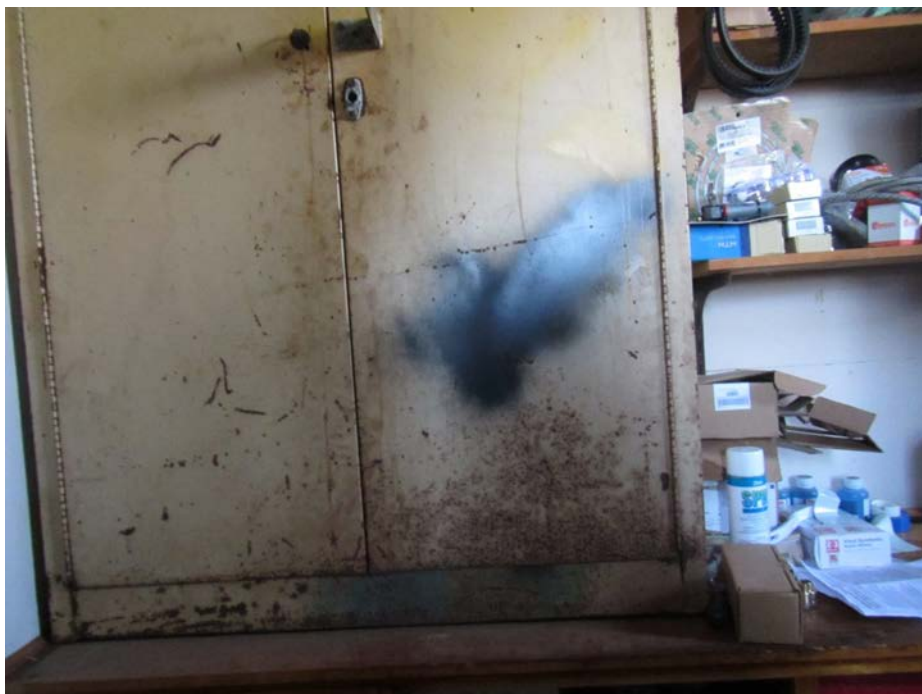
**Picture 14**

**Cabinet for flammable materials, could not be opened**

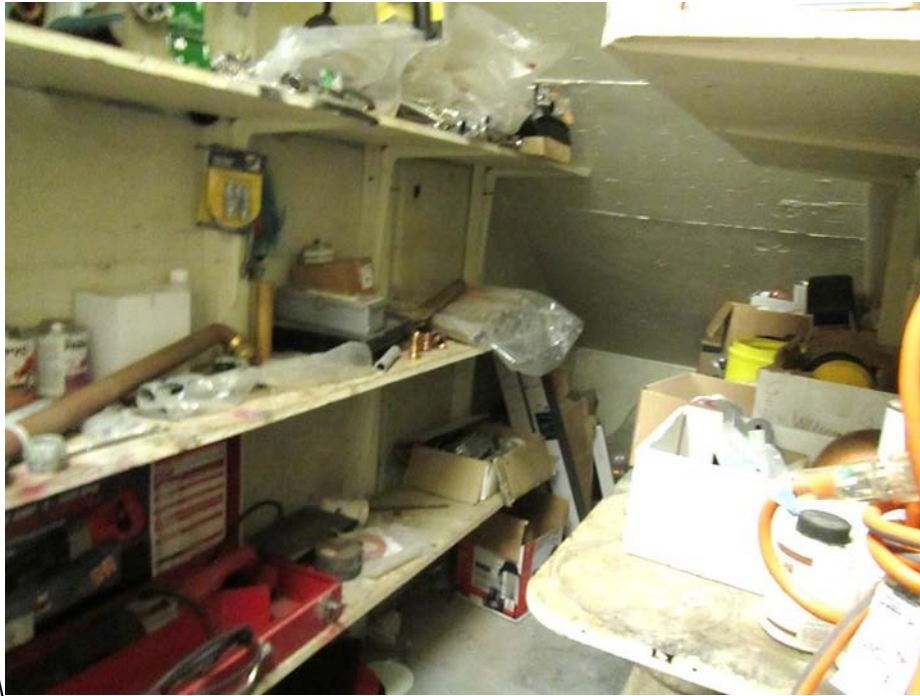
**Picture 15**

Storage of other materials, as shown in Pictures 15 and 16, are also disorganized. These conditions can lead to safety concerns as well as the build-up of dust and debris which may be reaerosolized and cause irritation. Items should be sorted and organized, with unneeded items discarded appropriately and other items neatly stored to allow for easy access and cleaning.

**Storage shelves in need of cleaning and organization**

12. Sort items stored in the workshop to remove anything no longer needed and store the remaining items in an organized manner that is easy to access and clean.

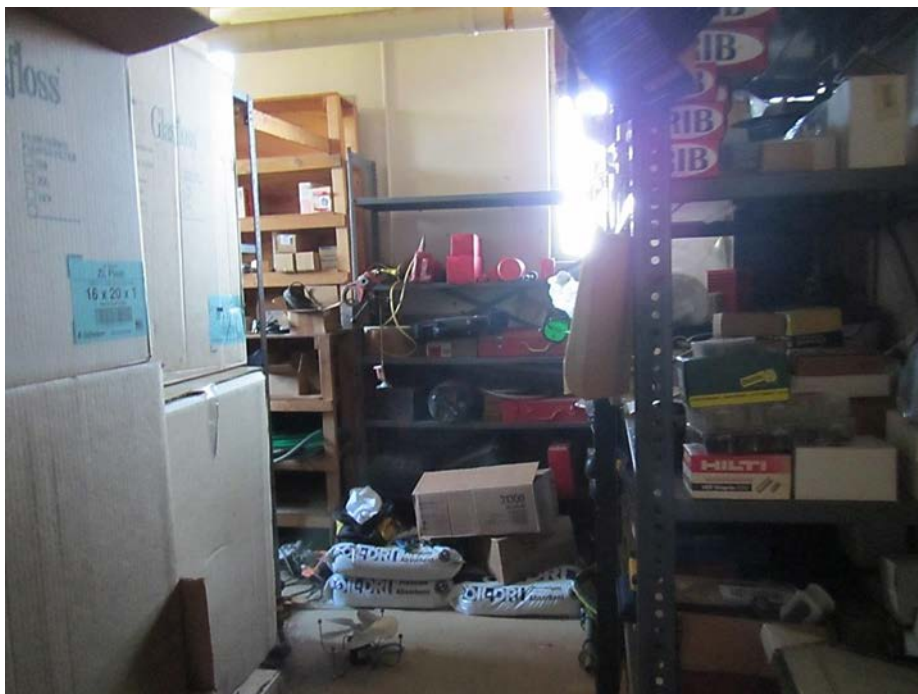
**Picture 16**

Boxes and numerous other items were found on the floor in the workshop area. Floors may be subject to condensation when they are cooler than the surrounding air and this may moisten materials stored on them.

**Storage of items, note items on the floor where they may be moistened by condensation**

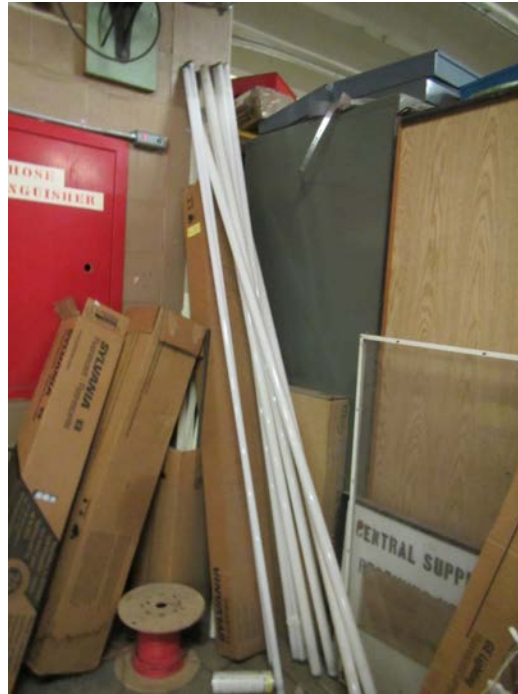
**Picture 17**

Spent fluorescent light bulbs were observed to be stored without proper containment (Picture 17); accidental breakage of these bulbs can release glass and powders which may contain mercury.

**Fluorescent bulbs stored in an insecure manner**

15. Store fluorescent light bulbs in boxes or other containers to avoid breakage, and have the spent bulbs removed as soon as practical.
